Iron Burgonet Treatment Report

Kiplin Hall	Acc. # 1992.292	Conservator: S. Goel
Date: 05-08-2021	Lab no: 3791	
Object: Helmet	Material: Steel, Brass, Leather

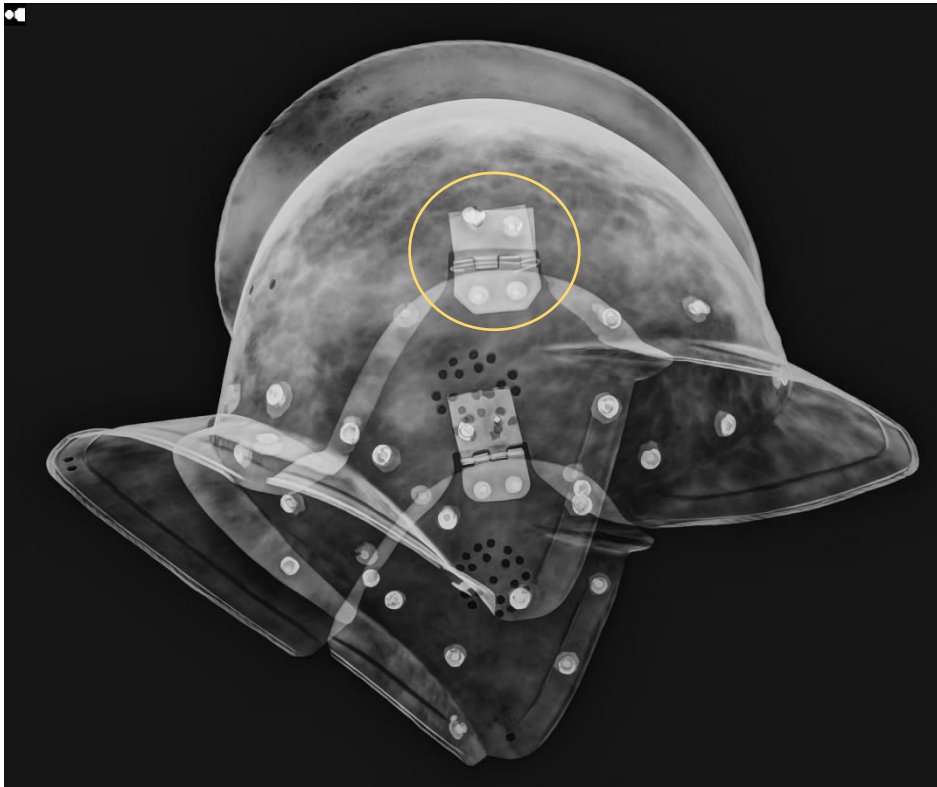
The x-ray (fig. 1) demonstrates that though there are rivets on the front of the helmet, the visor is part of the main body, not an added separate piece (Flynt). The x-ray also shows the loose wire that was used to repair the proper left ear flap.

*Figure 1: x-ray of the helmet demonstrating the historic fix on the proper right ear flap (circled)
(photo by Vicky Garlick)*

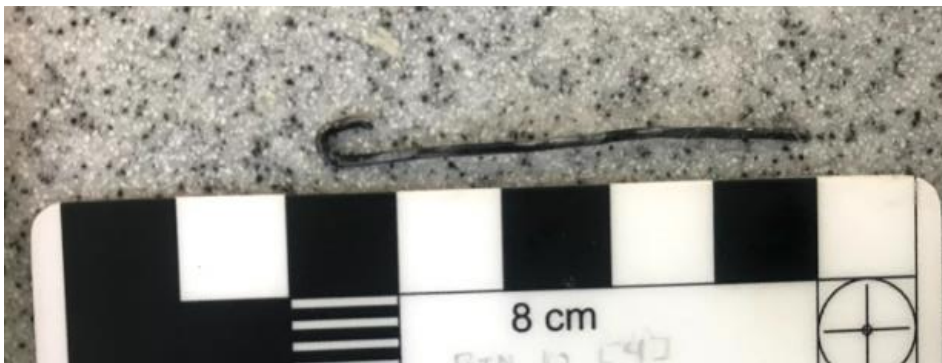
Figure 2: The wire of the historic repair of the ear flap after being removed. It was then cleaned using steel wool and 3-in-one oil, as was the hole it threaded through before being re-threaded and bent back into place, tighter than previously to support the hinge (photo by author)

For the proper right ear flap, the historic wire was removed and straightened out (fig. 2). The thread was cleaned up and the wire was reinstalled and tightened in order to limit further shifting and strain on the hinge. This was chosen as it was the least invasive option. The larger rivet on this ear flap was also consolidated using 40% paraloid B72 in acetone and glass microballoons which limits the strain and wear of the rivet on the helmet.

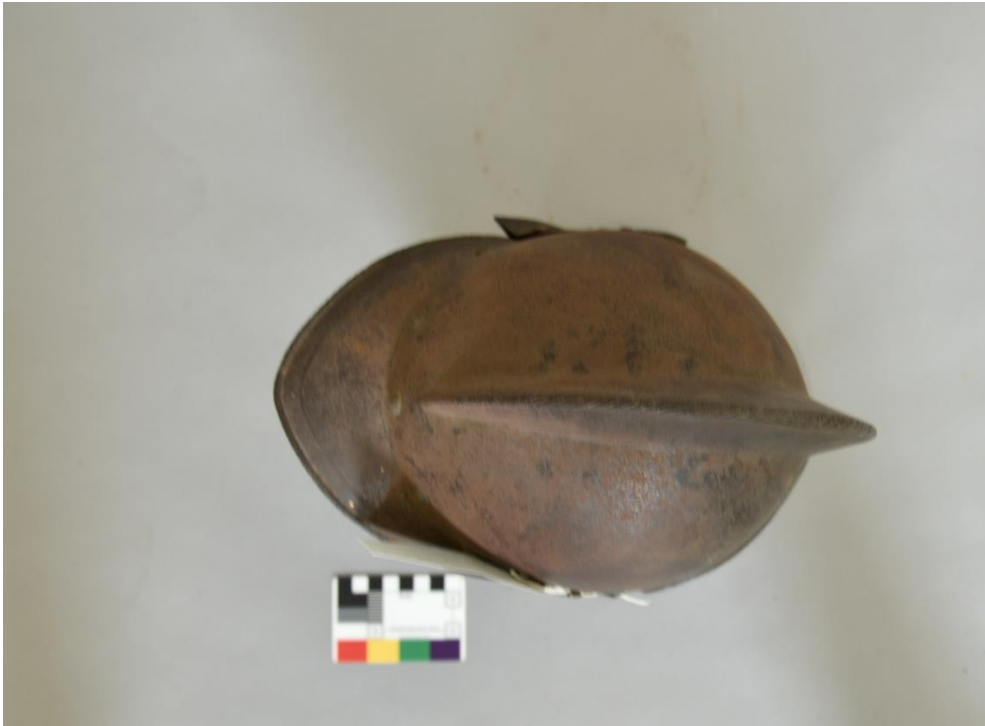
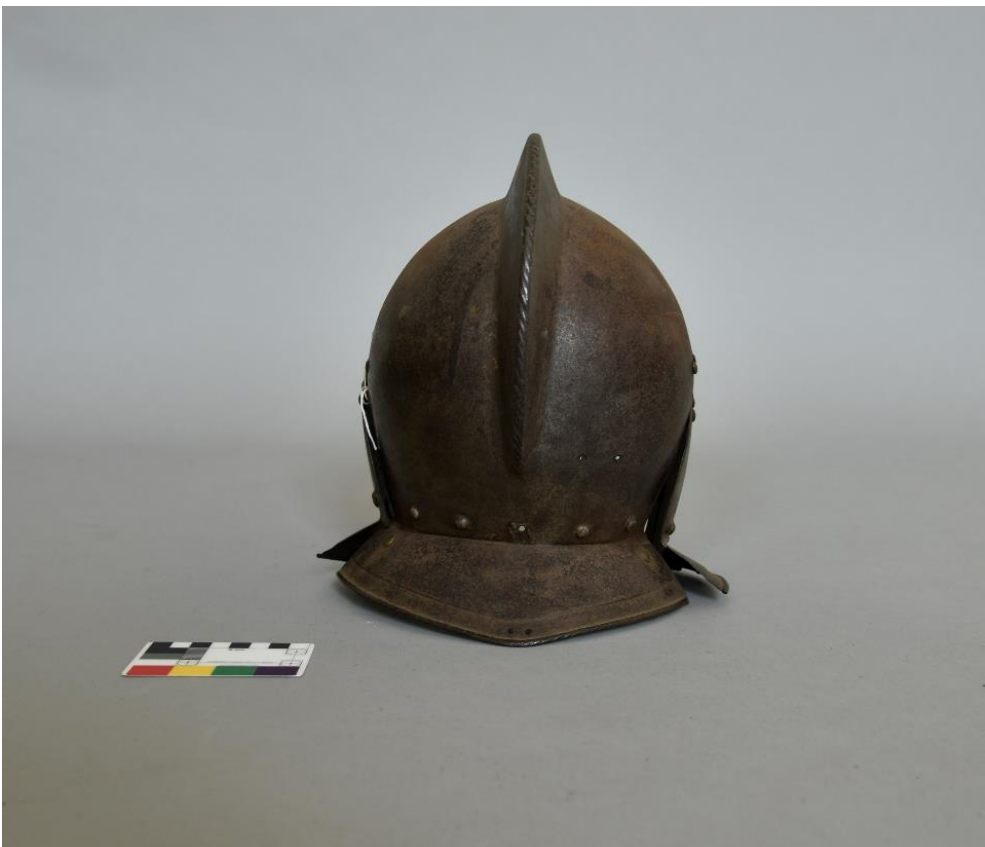
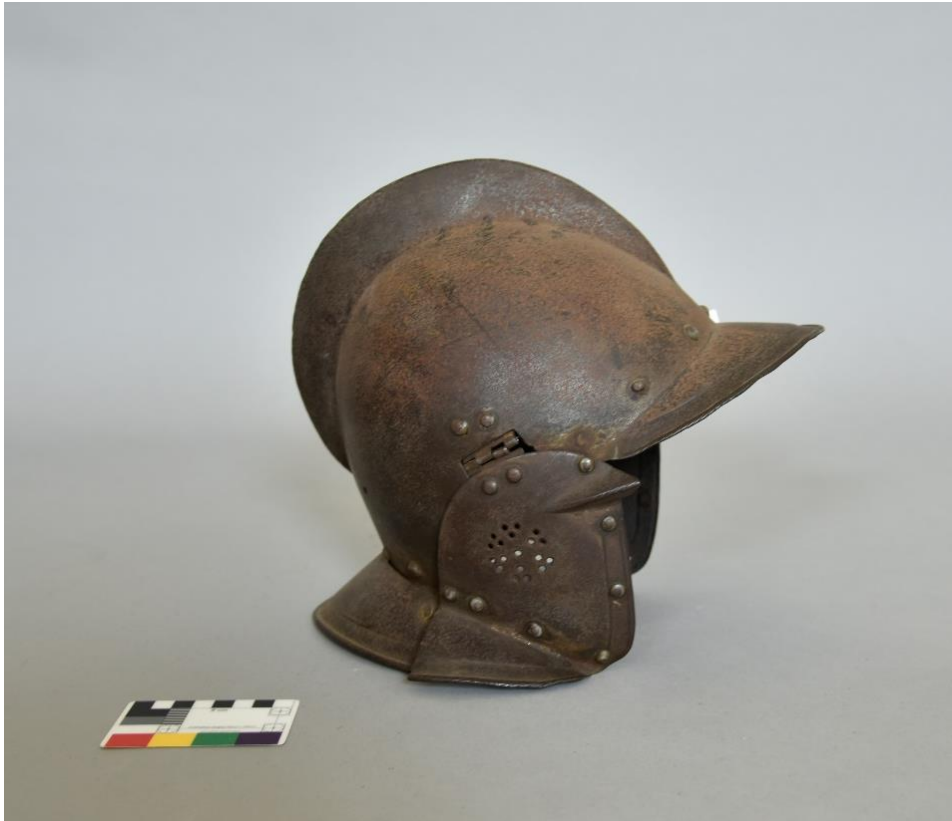
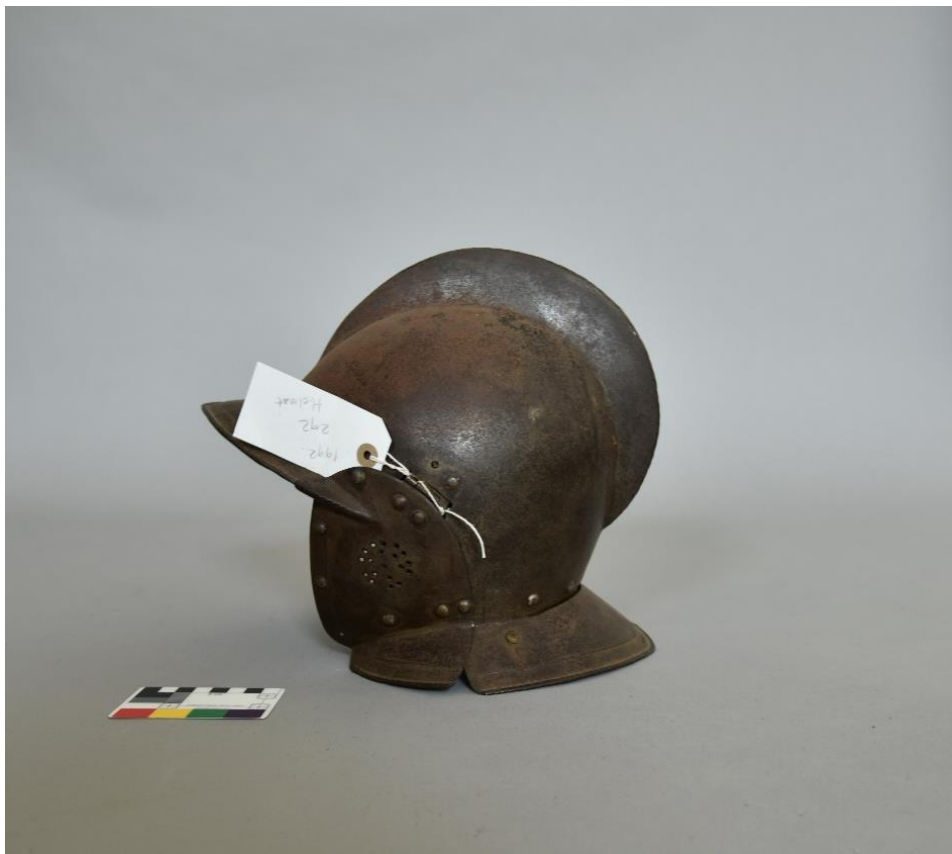
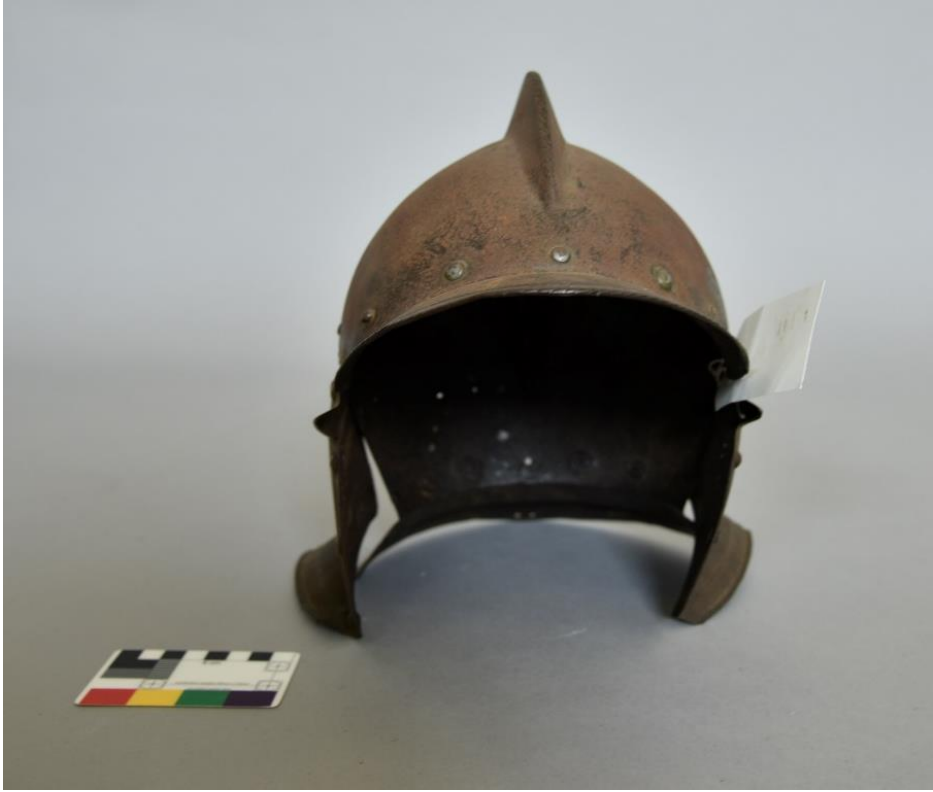
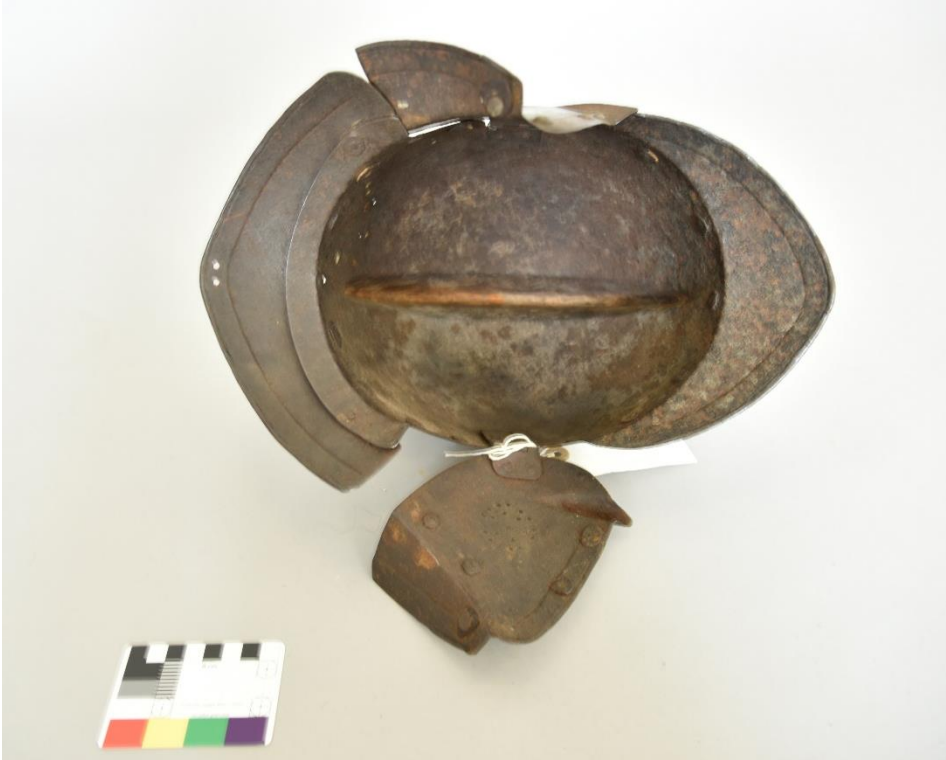
Before Treatment:

The helmet is relatively corroded, most of the layers are stable, however active corrosion can be seen on the surface and in the inner section of the ridge in the form of orange, powdery bloom. There is also white bloom on either ear flap. The main body of the helmet is missing two rivets but is generally stable. However, both of the ear flaps are slightly loose due to wear on the rivets. On the proper left side of the helmet, one rivet is missing on the ear flap, causing the hinge to be extremely loose. On the other earflap, there is evidence of a previous repair to the hinge in the form of a long wire replacing the original hinge. However, there is no previous conservation work recorded for this helmet, suggesting that this repair is historic (van Hak, pers. Comms.). An unknown waxy residue can be seen in some of the perforations on the ear flaps and on the inside of the back of the helmet.
