Owner: Missouri Historical Society	Acc #: 2004.058.0001	Date: 06/03/2023
Object: ACT UP Prop Coffin	Materials: Duct tape, cardboard, foamcore, posterboard, spray paint, acrylic paint

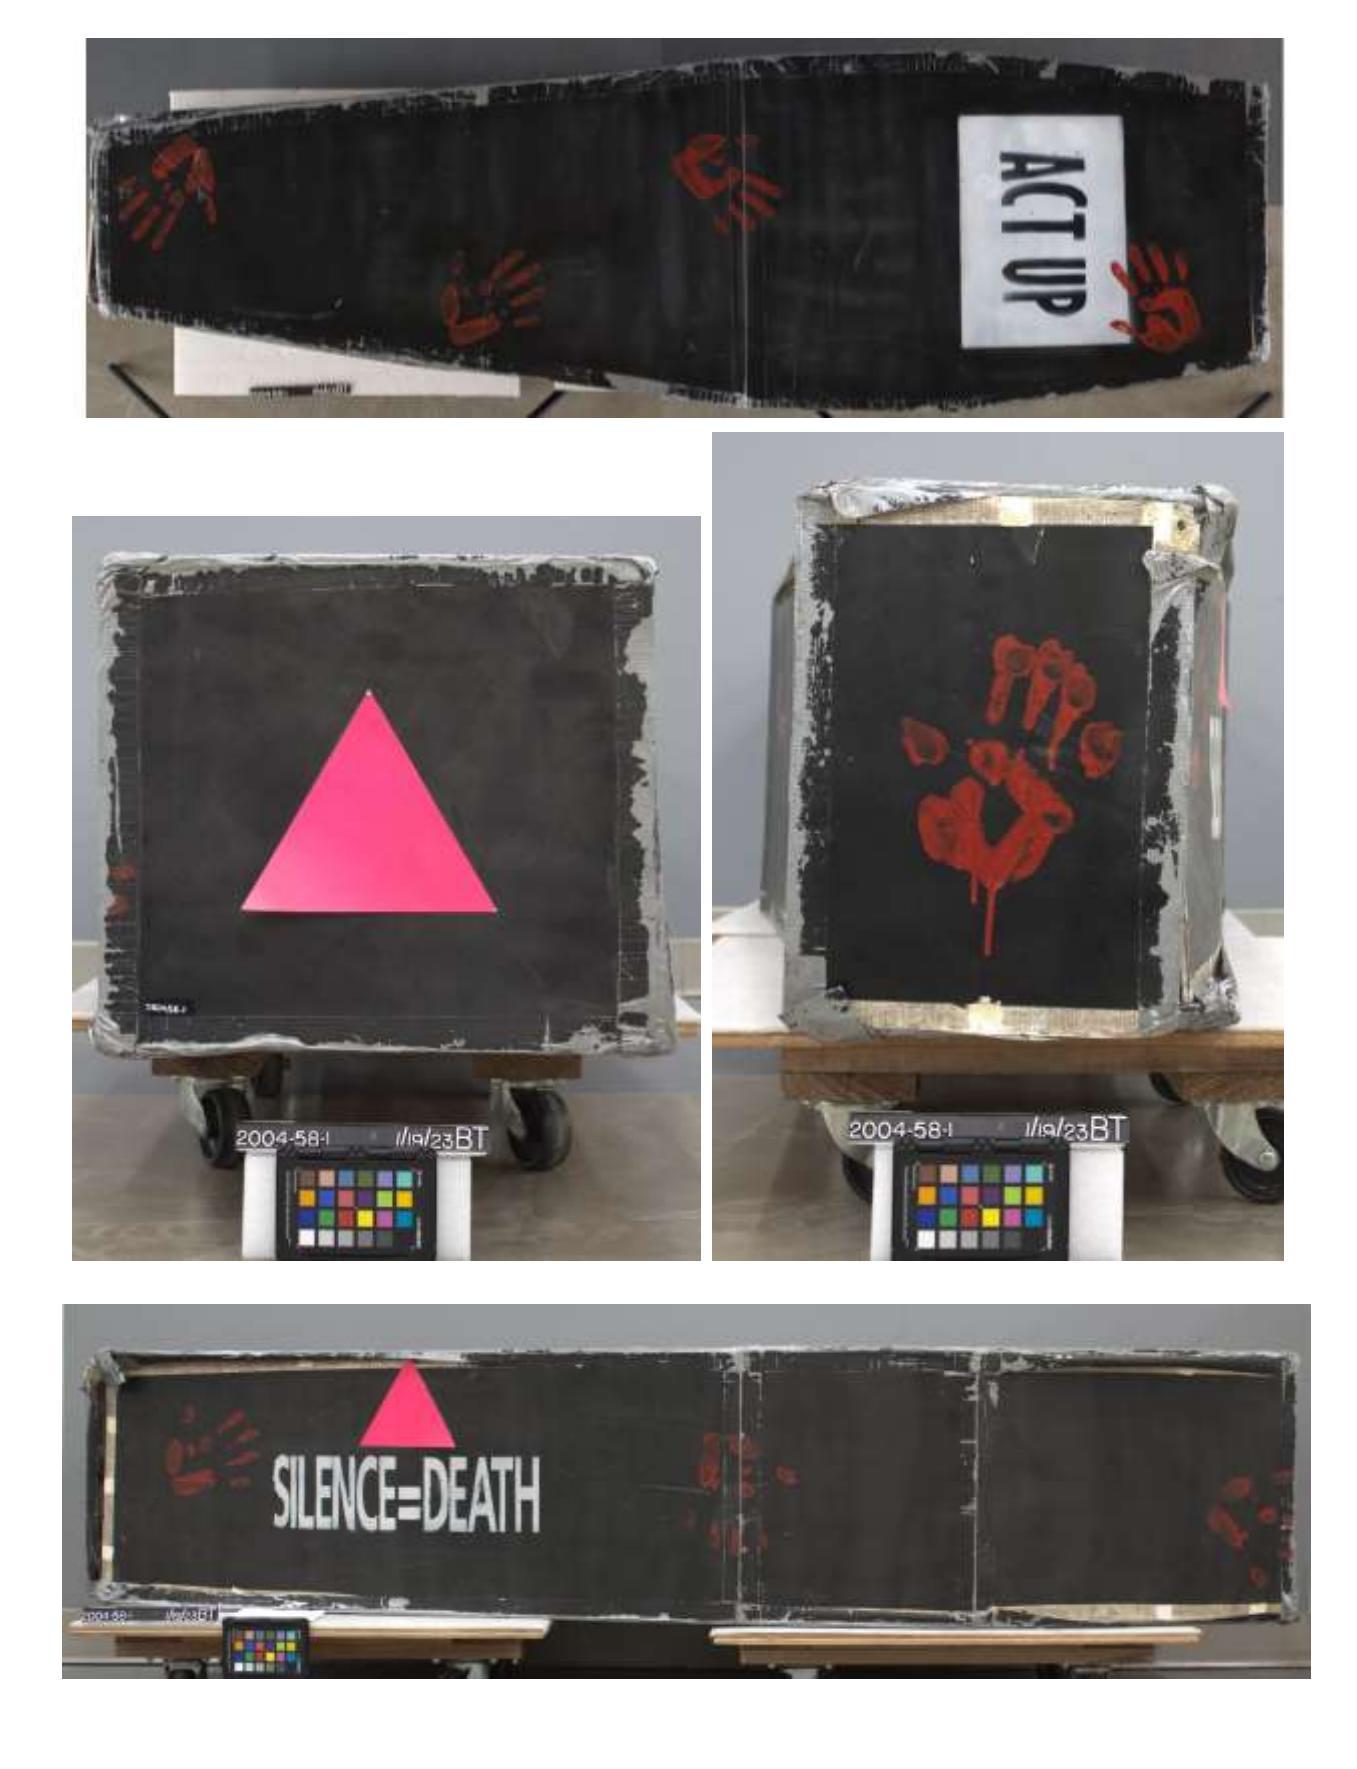
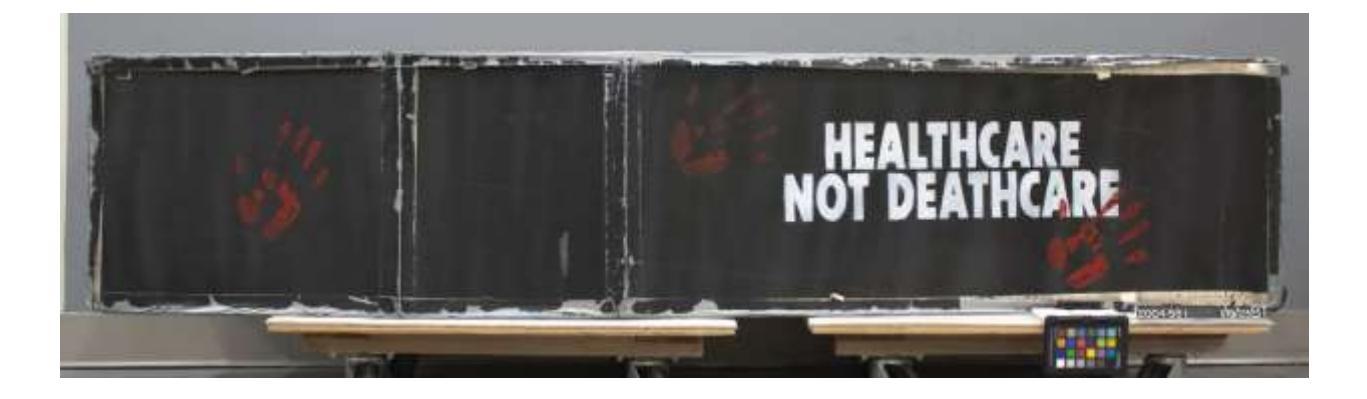
Before Treatment

Despite the belief that duct-tape and other plastics are forever, after twenty years in the collection, the coffin demonstrates serious deterioration. The duct-tape adhering the foam board together has failed throughout the piece, leaving it at risk for deformation and complete breakage. This is most noticeable at the foot of the coffin, where the foam core had detached so far as to see the interior of the object. The two shorter side panels of the coffin demonstrate minor warping due to pressure created by the manufacture of the object, however it is made more obvious due to the loss of adhesion between the board and the duct tape. The duct tape failure was likely caused by fluctuations in humidity over time, causing the deterioration of the adhesive. Furthermore, general exposure to oxygen can break the bonds of the plastic component in duct tape (Blank, 1990). The flexibility and constant manipulation of the duct tape layers has caused paint to flake, and loss is evident on the majority of the duct-tape covered surfaces.

Beyond the adhesive failure, the coffin is generally dirty and demonstrates a few dents and scratches. This is likely due to the static susceptibility of the materials, as well as its use in various outdoor settings. The matte paint over the polystyrene also lends itself to static charge, causing dust and soiling to accumulate easily.

Due to the instability of the paint layers present on the duct tape, it was determined that the consolidation of these areas was necessary prior to any other work on the object. This was performed by flushing areas using ethanol in order to ensure the proper flow of the 20% isinglass in deionised water solution between the paint and the polyethylene surfaces. This proved successful, as the isinglass allowed for a reasonable drying time and did not alter any surfaces. Furthermore, in areas where the paint was clearly not attached to the duct tape following consolidation attempts, the adhesive was reactivated using a heated spatula, applied through a mylar silicone release paper to ensure cohesion between the materials.

At the base of the coffin, it was clear that the object was not able to support itself, and therefore required extra support added to the structure. A triangular prism of double thickness blue archival board was adhered to the inside of the two foam core sides using Jade 403 as an easily removable support. This helps support the weight of the top piece of foam core as well as aids in remedying deformation at the foot of the coffin.

After the paint layers were consolidated, the duct tape could be manipulated without the risk of severe loss. This allowed the duct tape to be re-adhered to the foam core board. Based on the nature of both the foam core and the duct tape, it was determined that a water-soluble adhesive would be the best option for adhesion. Work produced by the National Museum of Air and Space demonstrated the successful use of Lascaux 498HV to re-adhere duct tape to other plastic surfaces (National Air and Space Museum 2020). This provided an excellent tackiness to the adhesive that ensured an ease in the adhesion as well as reasonable strength following its application, limiting possible adhesive failure in the future. In the area at the base of the coffin where the duct tape was considerably stiffer and more deformed, a PEL Preservation Pencil was used in order to humidify and heat the plastic slightly so it could be manipulated back into place and re-adhered.

In several areas, the duct tape could not be re-adhered due to bowing of the foam core panels. It was decided that in order to ensure the stability of these panels as well as the overall aesthetics of the object, that these panels should be manipulated back into their original place (evidenced where duct tape would be flush with panels and previous adhesive present on the adjoining panels. This was performed by applying 40% Paraloid B72 in acetone to the flat surface of the adjoining panel before levering the bowed panel into place and using weights to create proper pressure for adhesion. One of the panels demonstrated continued bowing even with adhesive. A heat gun was used in order to reactivate the adhesive and a metal spatula was used to hook under the panel and keep it in place whilst the adhesive set.
